An expanded assessment of risks from flooding in Luanda

2010

John Mendelsohn, Stephe Mendelsohn & Ndapewa Nakanyete

An assessment of flooding in Luanda: risks and damage

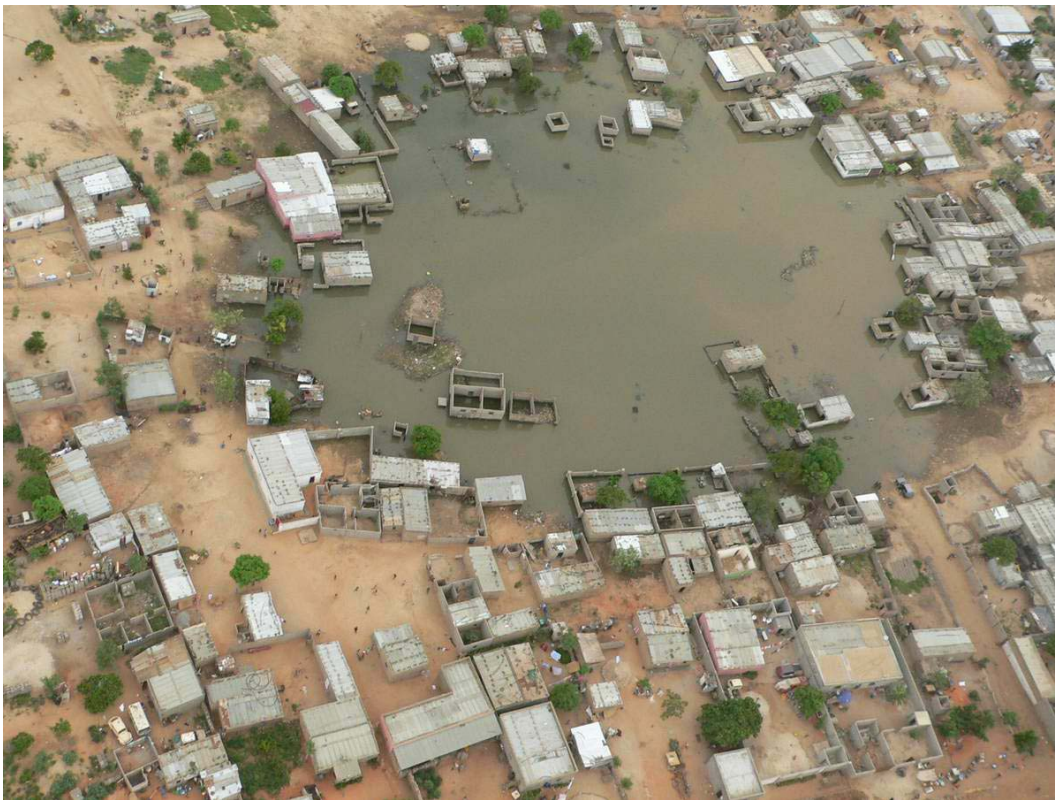
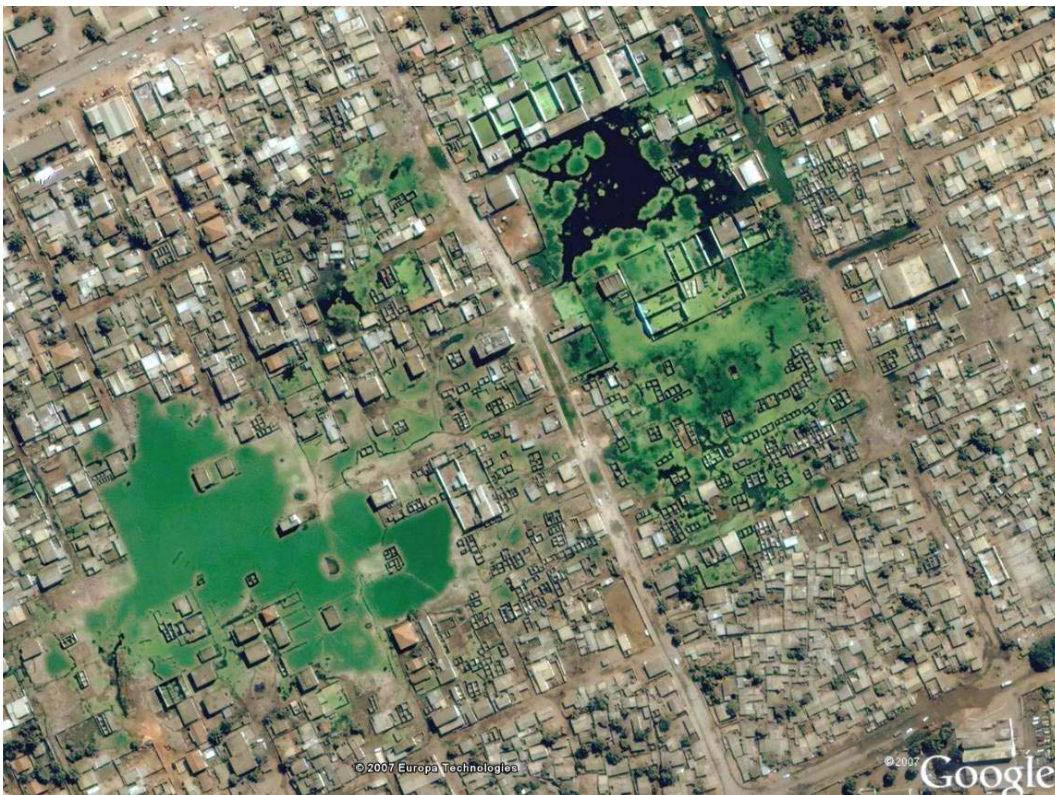
Examples of flood areas identified from the aerial survey (top) and those to be seen in satellite images provided by Google Earth. Note the abandoned houses with no roofs in both images.

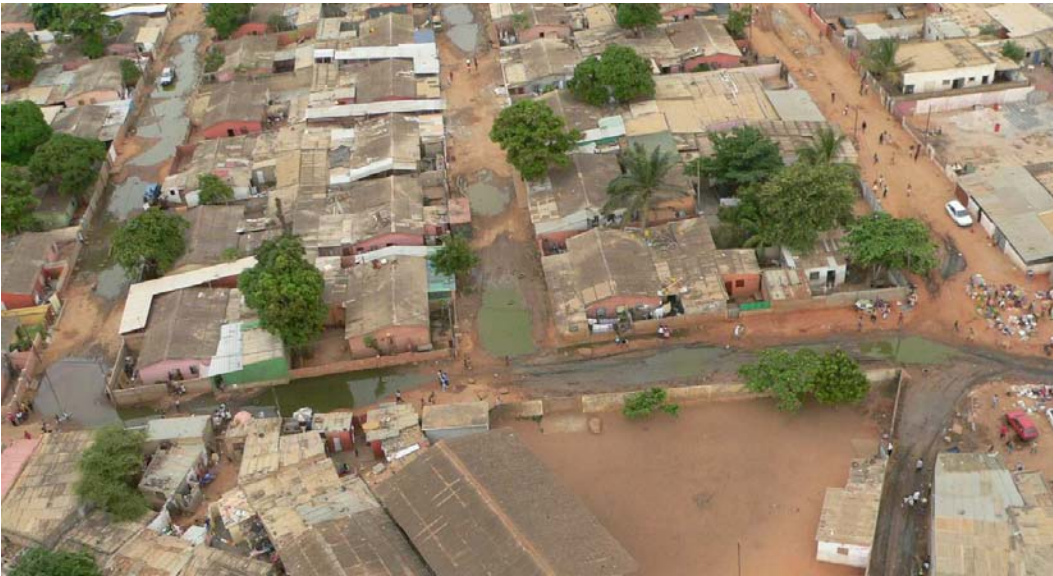
The remnants of sheet flooding as pools of water lying in roads. The houses around these roads would have been flooded after the heaviest rains.

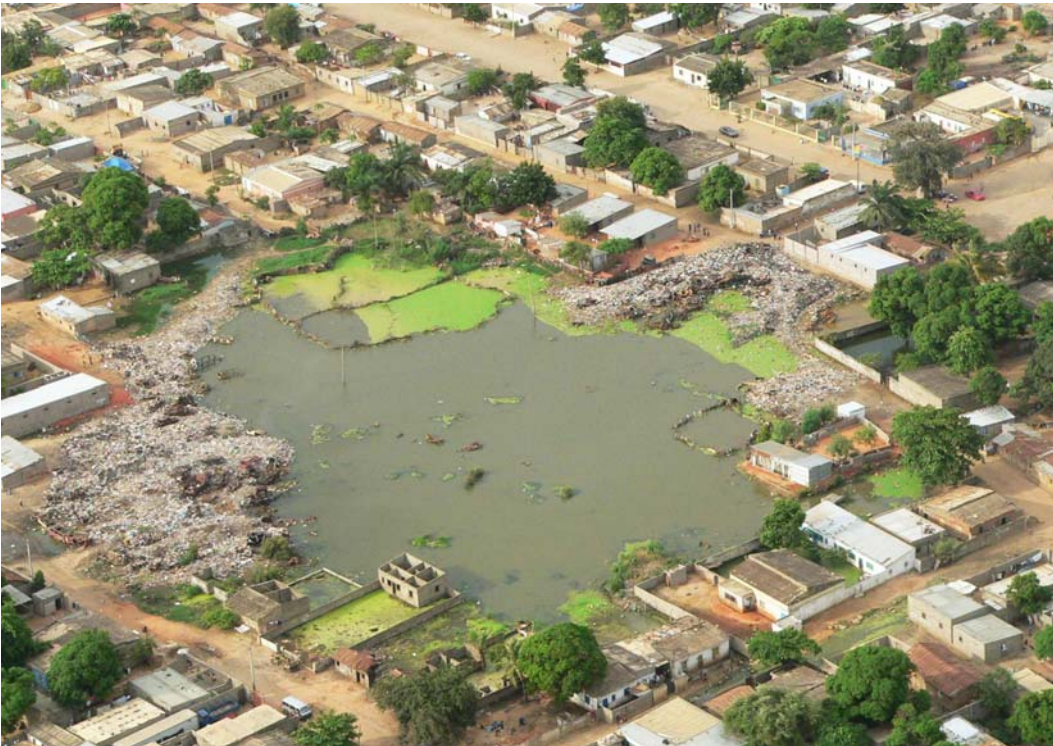
A typical stagnant pool surrounded by massive accumulations of rubbish and growths of algae on the water surface

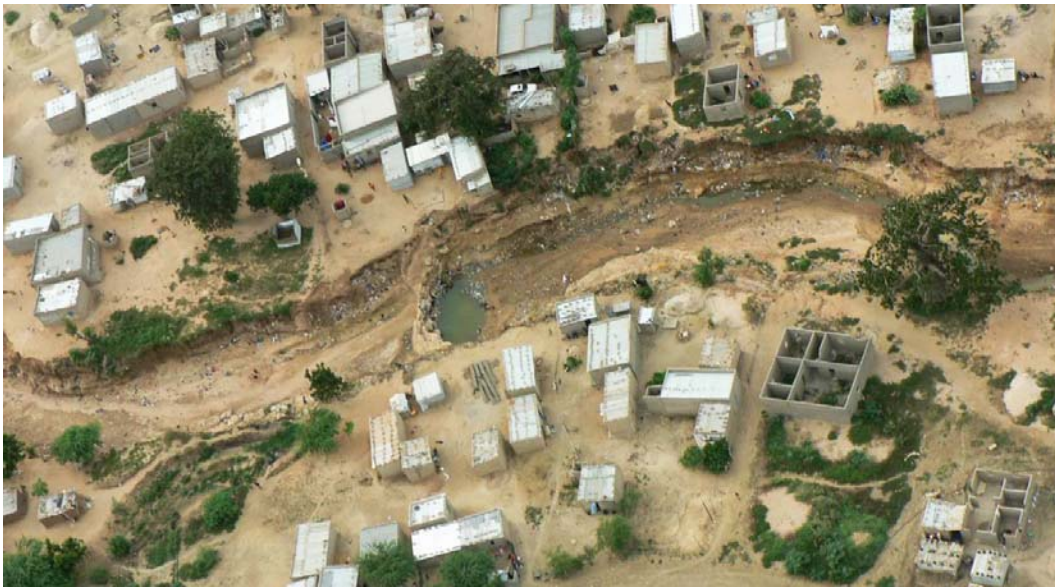
Blockages along drainage lines led to surges of water causing severe erosion which undermined the foundations of nearby homes.

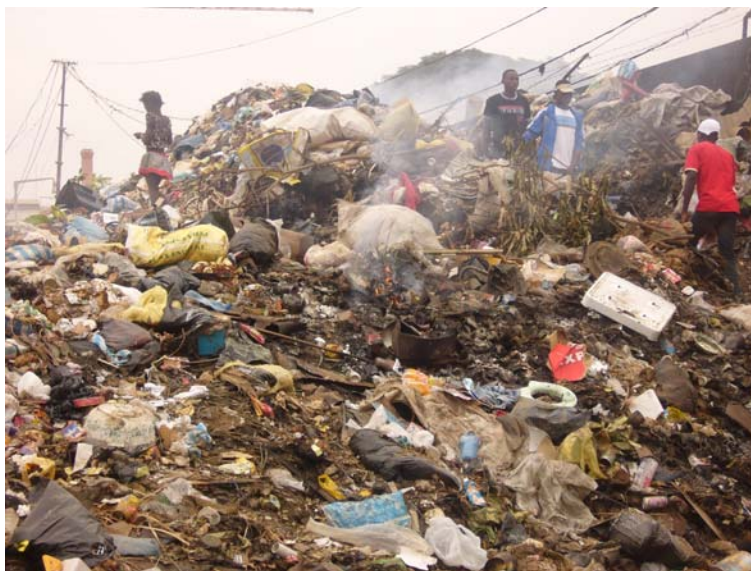
Mounds of rubbish being burnt along a road, a method used to dispose of domestic waste by 39% of the homes surveyed.

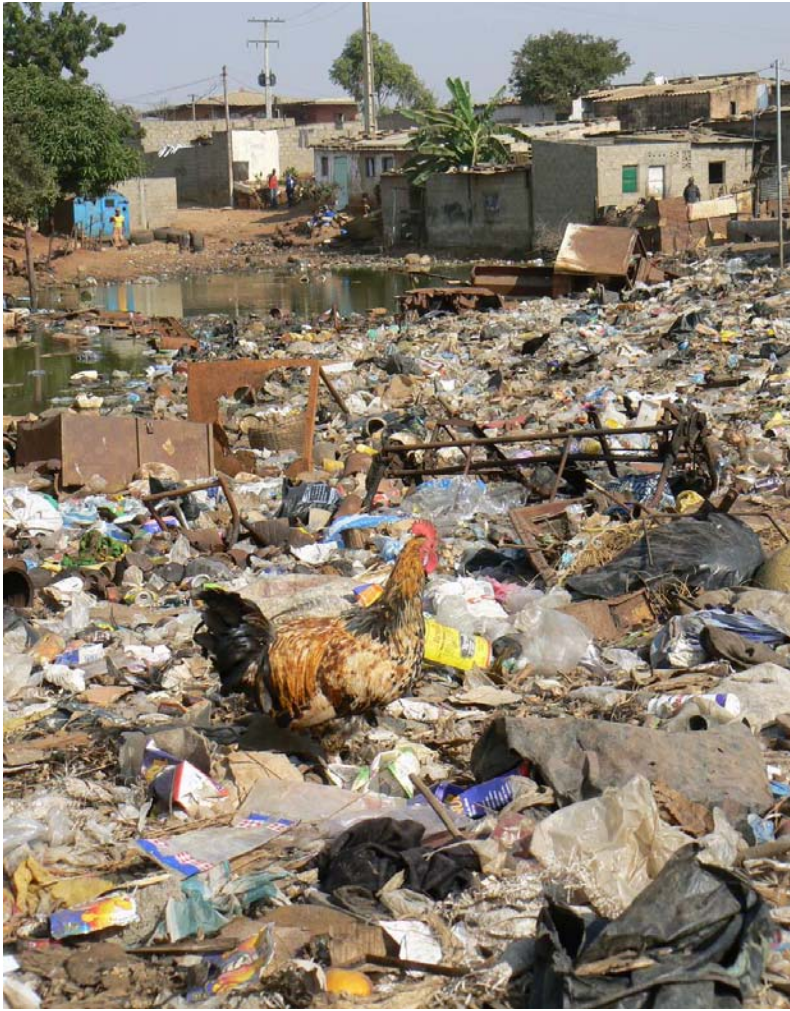
Years of rubbish are piled up in this pond of stagnant water (top) while children use sheets of cloth to net tiny fish and shrimps from a pool that remains filled with water months after the heavy rains early in 2007.
